FINDING OF EFFECT

Sam and Alfreda Maloof Compound Roof Replacement
(Main House, Workshop 1, Workshop 2, and Guest House)
Alta Loma, Rancho Cucamonga, San Bernadino County, California

June 30, 2023

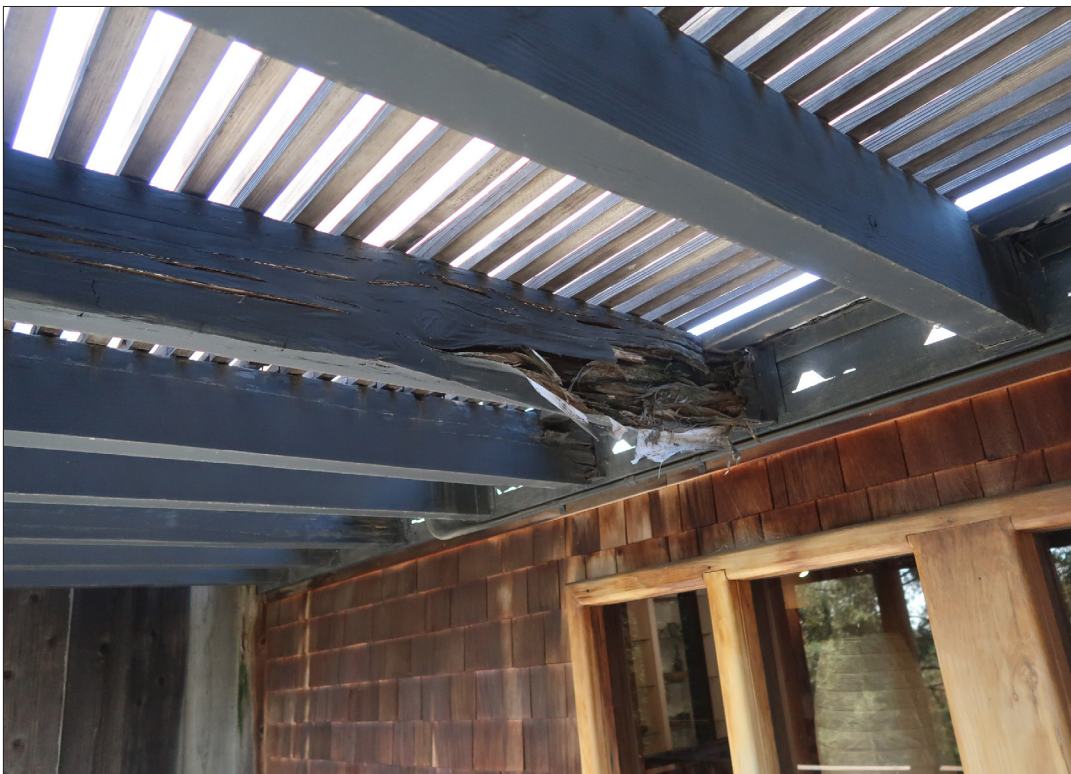
Image 18: Detail of deteriorating rafter at south balcony, view northwest (Chattel, 2022)

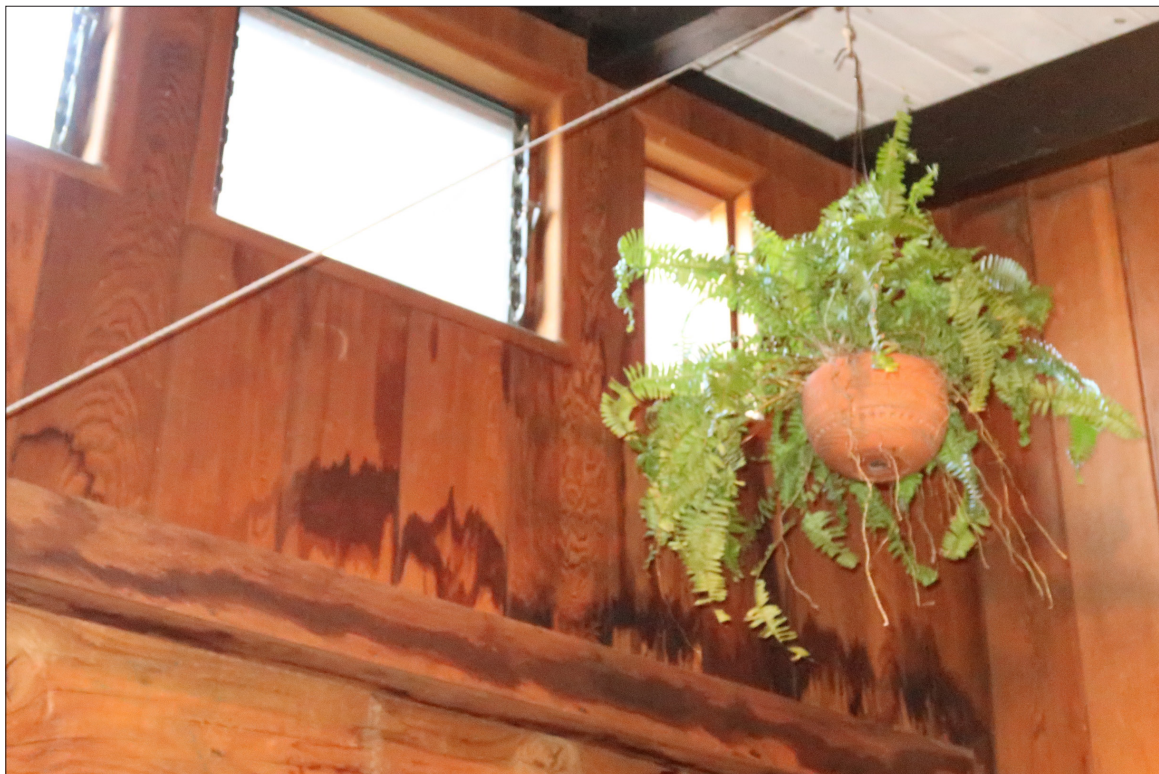
Image 24: Detail of water damage on wood clad walls (Chattel, 2022)

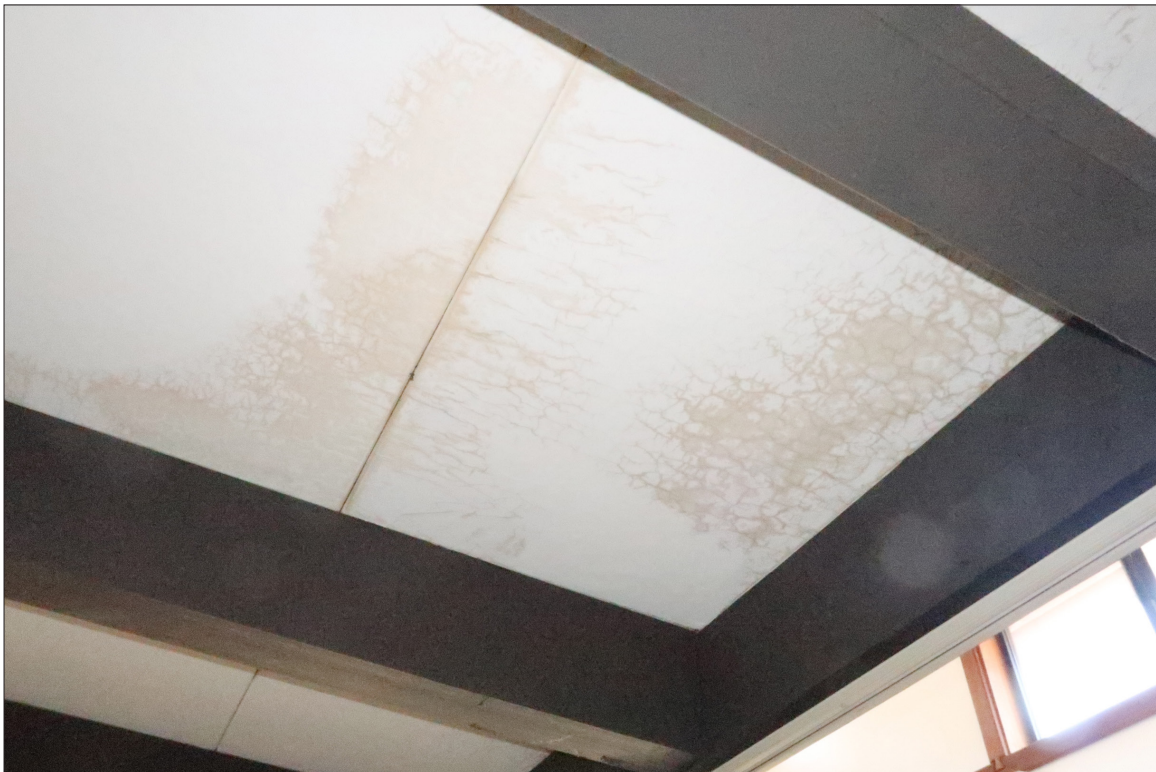
Image 26: Detail of water damage at ceiling (Chattel, 2022)

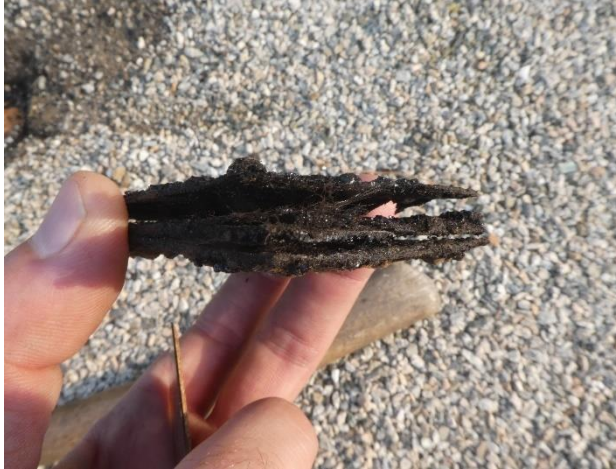
Figure 2. Three plies of the roofing felt were identified to be saturated and partially separated with hot-applied asphalt waterproofing

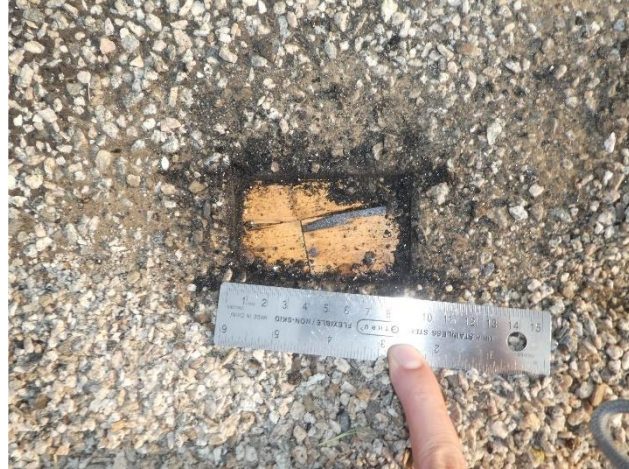
Figure 3. In most areas the roofing assembly was installed directly onto the wood roofing substrate, photograph from the Visitor Center.

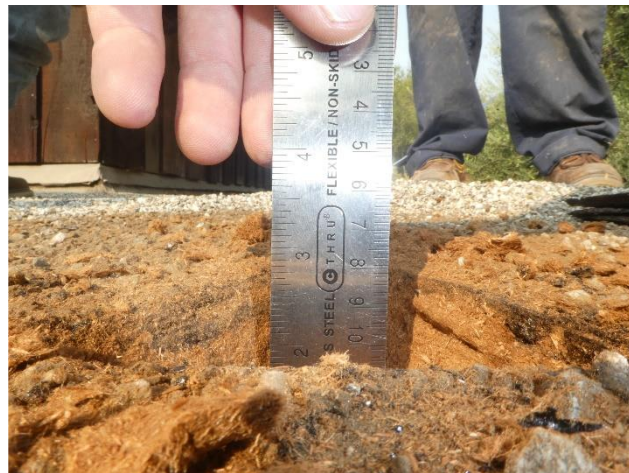
Figure 5. The depth of the roof core location, including the roof assembly and substrate measured approximately 2-3/4 inches.

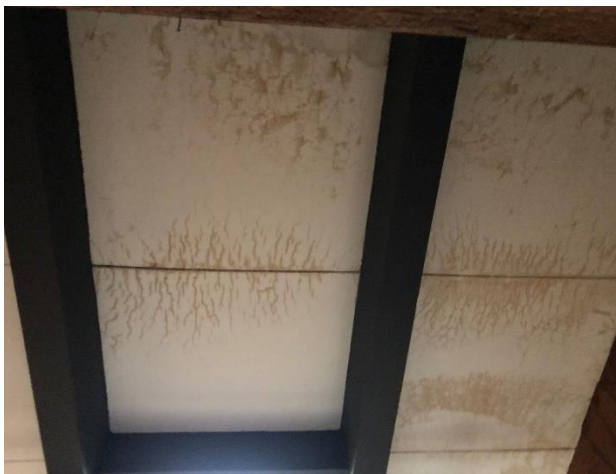
Figure 6. Water damaged fiberboards near the kitchen skylights

- Conference Room Patio Area will require modification to include wood sheathing and assessment of the conditions of the existing fiberboard.
- Replacement of the existing fiberboard should be anticipated.

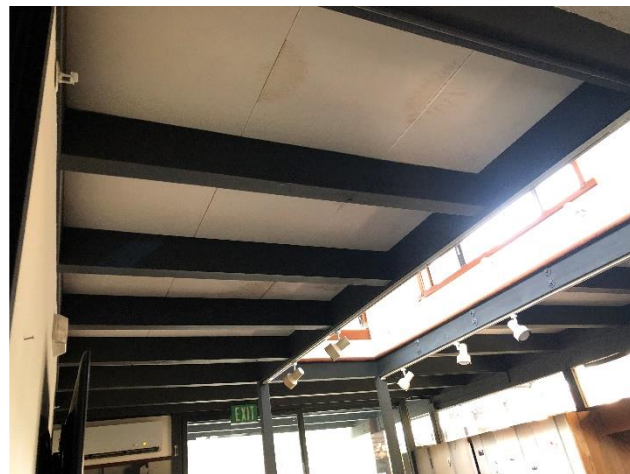
Figure 7. Water damaged fiberboards in the conference room

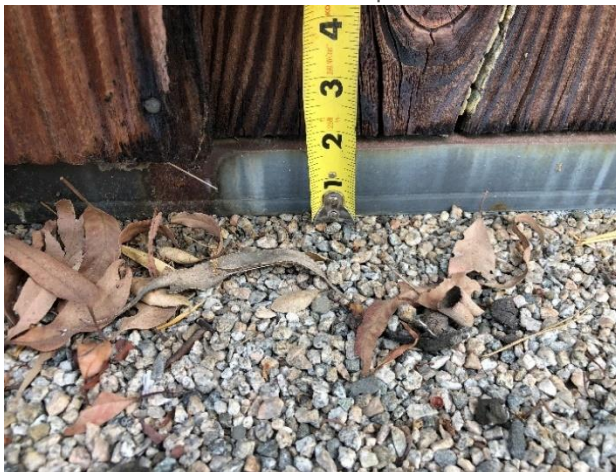
Figure 8. Vertical siding with minimal clearance at the Workshop 1 West Addition

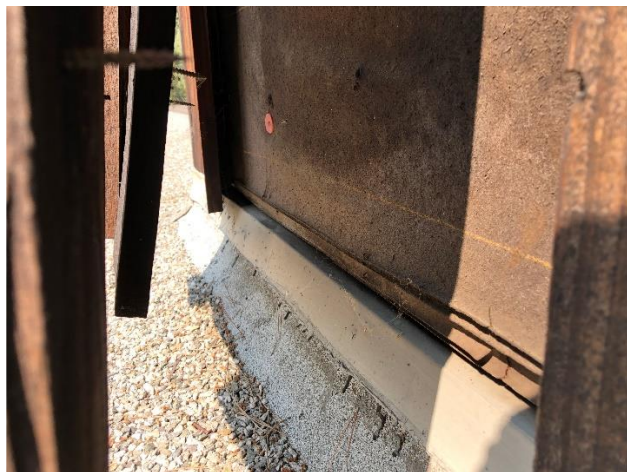
Figure 9. Location where vertical board bottom fasteners are withdrawn showing that enough room is available with bottom fasteners removed to replace base flashings.

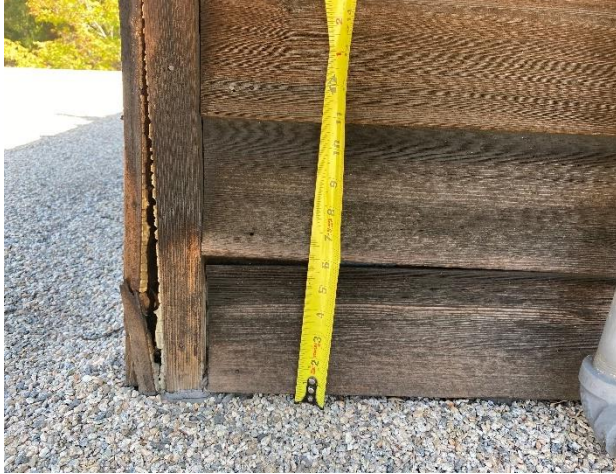
Figure 10. Horizontal siding with very little clearance at the Visitor Center/Gift Shop

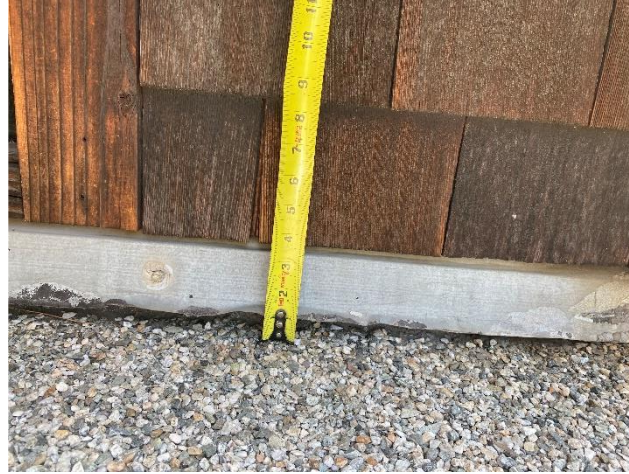
Figure 11. Shingle siding with minimal clearance at the Main House (east)

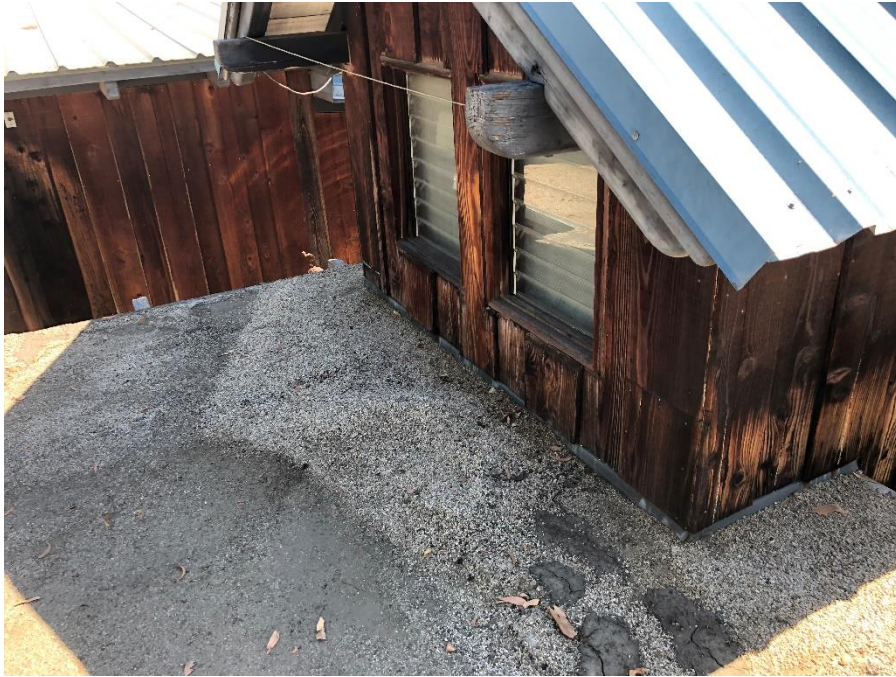
Figure 19. Example at rising wall with vertical siding and limited vertical flashing height below industry standard recommendations. This area is largely unseen from elsewhere on site.

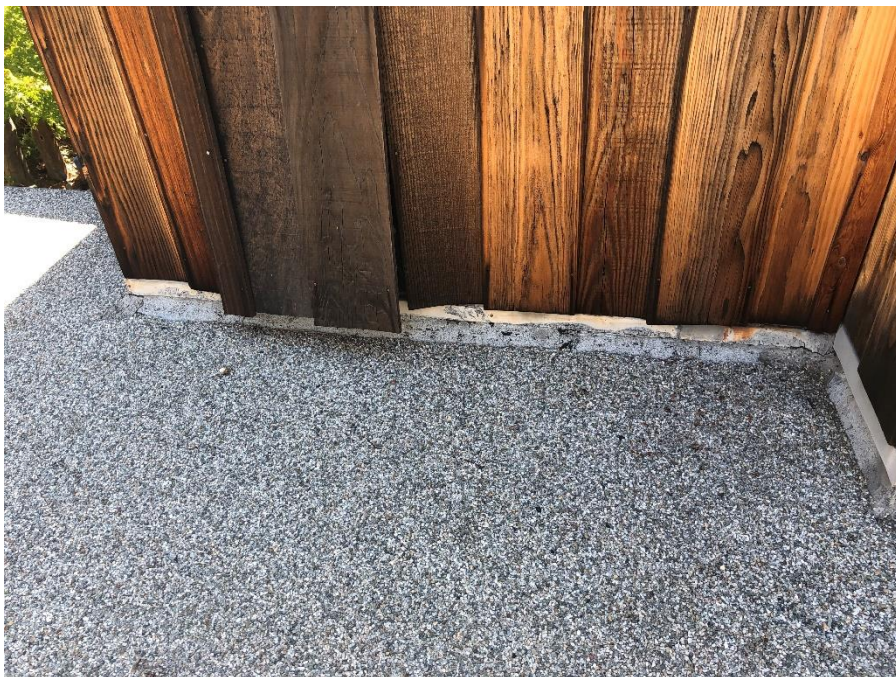
Figure 20. Example at rising wall with vertical siding and limited vertical flashing height below industry standard recommendations. This area is largely unseen from elsewhere on site.

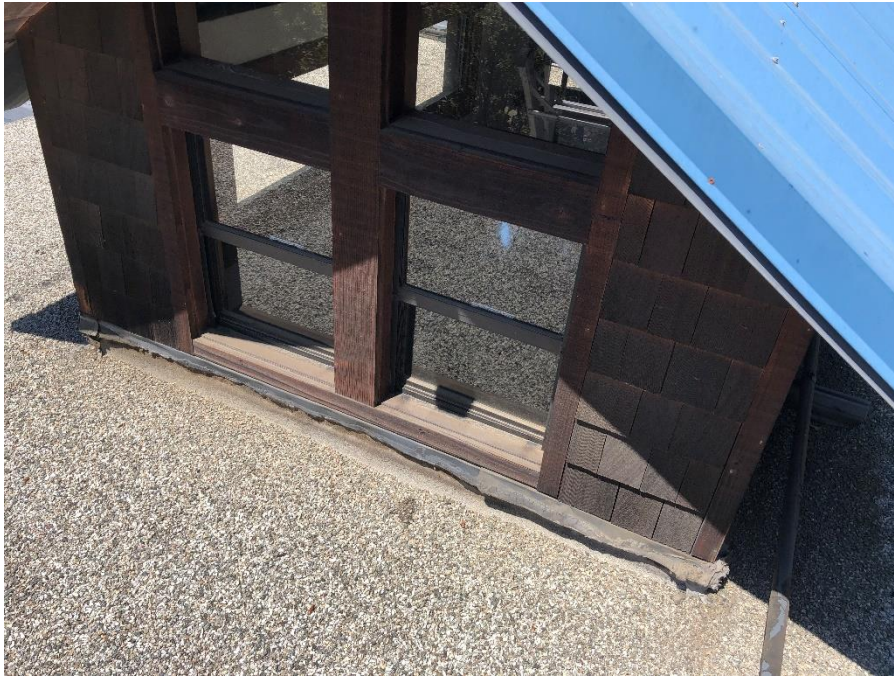
Figure 21. Example at rising wall with window and shingle cladding along with limited vertical flashing height below industry standard recommendations.

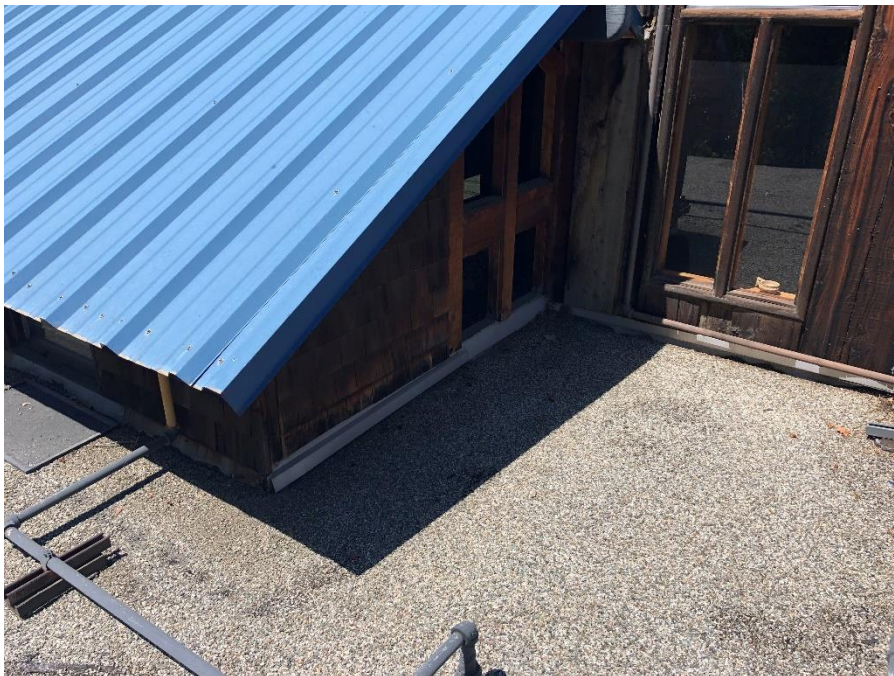
Figure 22. Example at rising wall with window and shingle cladding along with limited vertical flashing height below industry standard recommendations.

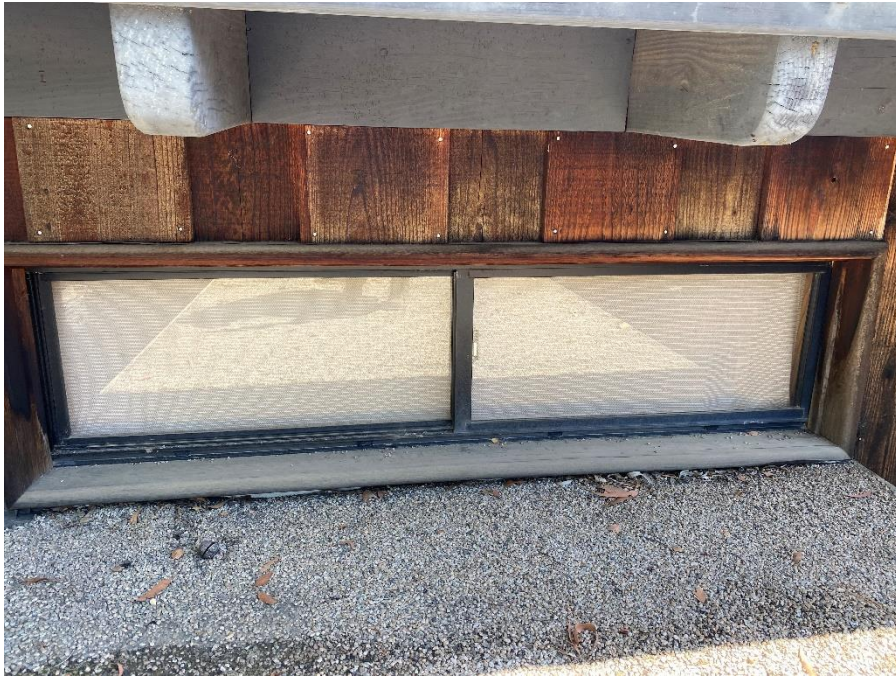
Figure 23. Example of very little available flashing height below existing window.
