FINDING OF EFFECT

Sam and Alfreda Maloof Compound Roof Replacement
(Main House, Workshop 1, Workshop 2, and Guest House)
Alta Loma, Rancho Cucamonga, San Bernadino County, California

June 30, 2023

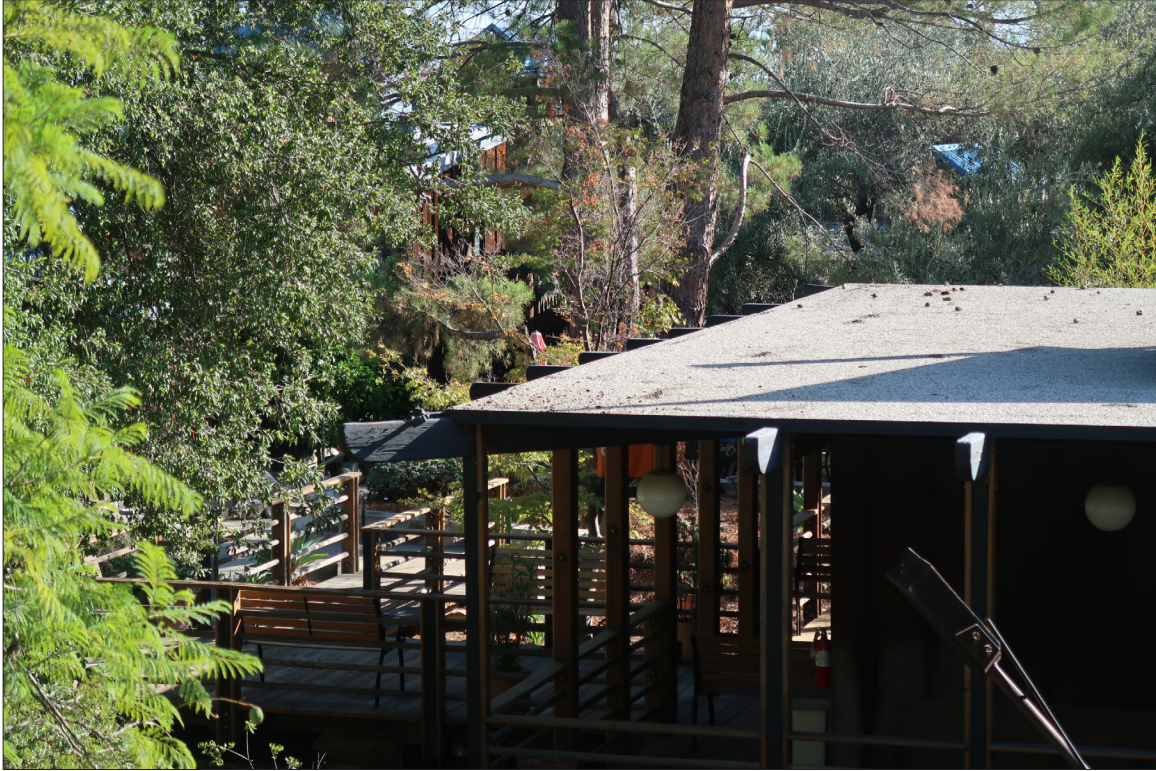
Image 29: Detail of built-up asphalt roof with gravel surfacing at Guest House, view southwest (Chattel, 2022)

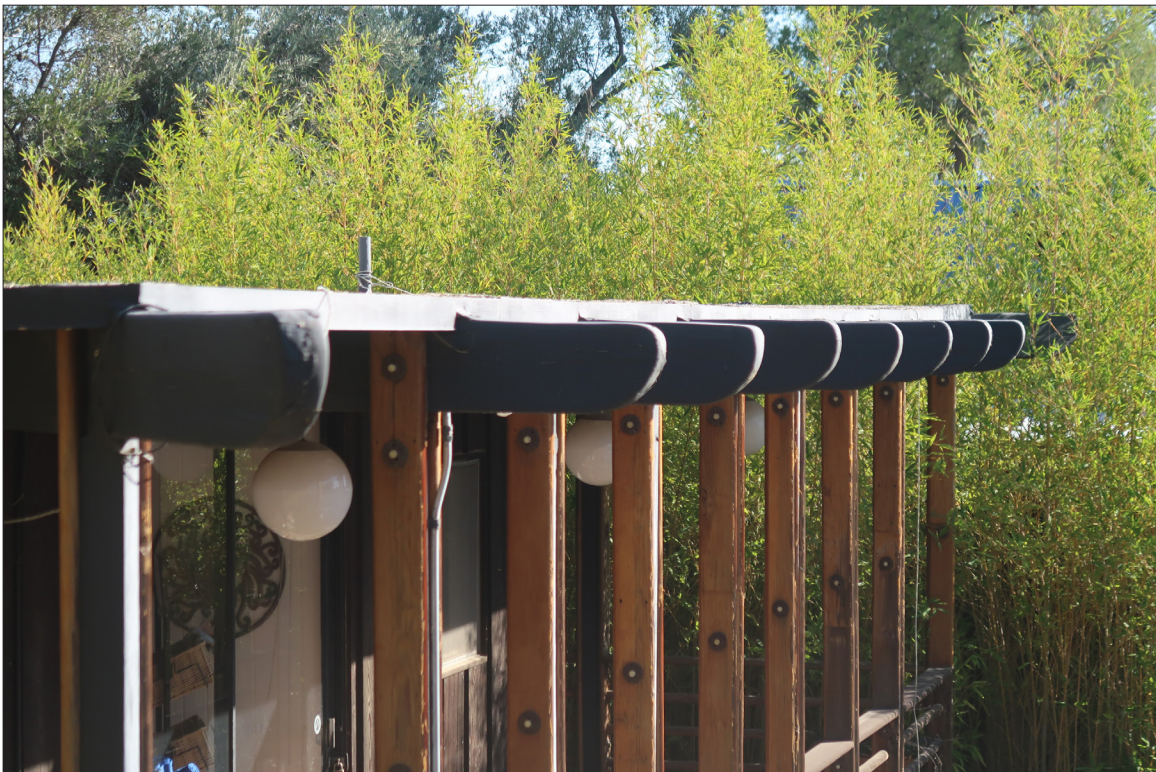
Image 30: Detail of rafters at Guest House roof (Chattel, 2022)

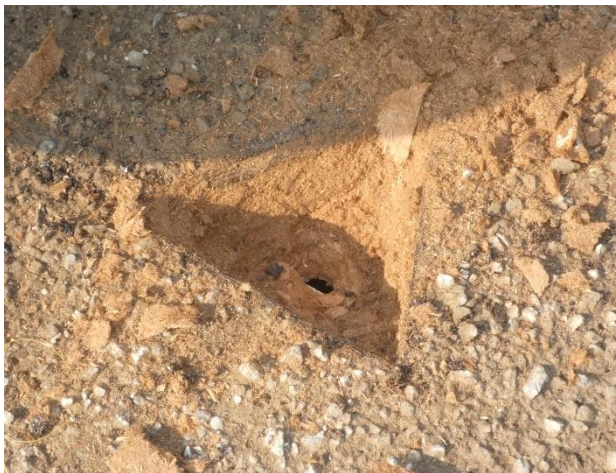
One of the roof cores completed at the patio end (north) of the conference room included the BUR assembly directly applied to the existing fiberboard sheathing/insulation.

Figure 4. Roof core created at the conference room, north. The roofing assembly was installed directly onto the insulation/fiberboard substrate. The roofing assembly was measured at approximately 1/2 inch.

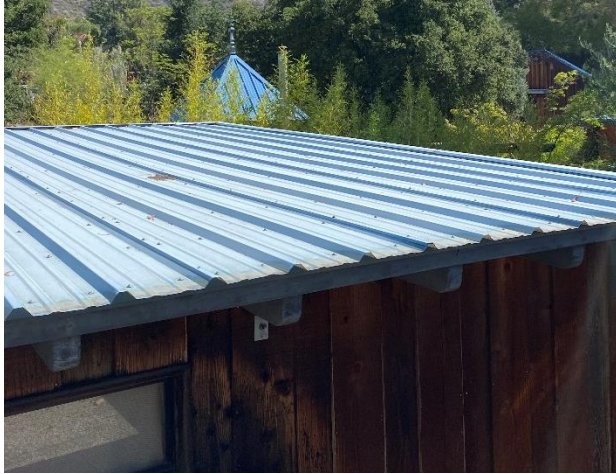
- NRCA recommends a minimum 3:12 slope for all architectural metal panel roof systems. The existing slope for the shed roofs is below industry standard for a metal roof system. Metal roofs that are sloped below NRCA guidelines are more vulnerable to water infiltration.
- It is recommended that exposed roofing fasteners are diligently replaced when neoprene gaskets deteriorate due to ultraviolet light (typically around 10 years). Because of the low slope of these roofs, fastener condition becomes of greater importance.
- This replacement is an in-kind replacement and therefore would appear similar to the existing

Figure 12. Existing metal panel roof profile

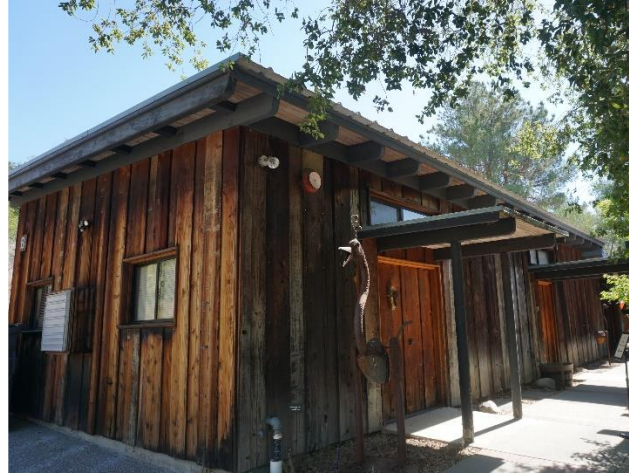
Figure 13. Current view of Workshop 2 metal roof perimeter from walkway level

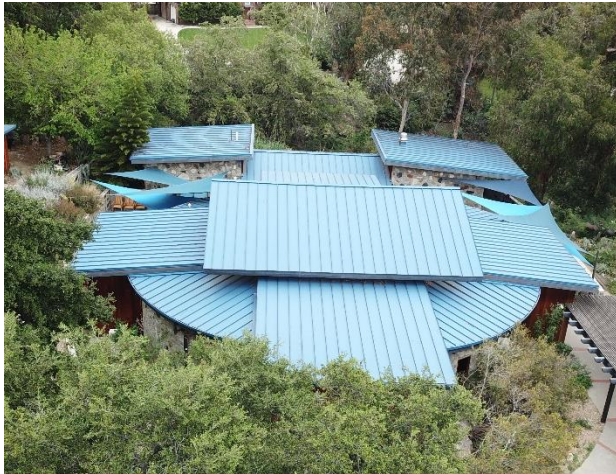
- Although standing seam roofs offer better reliability in moisture control than trapezoidal roofs because fasteners are concealed, the low pitch of the roofs is still below NRCA guidelines for metal panel roofing. Therefore, standing seam roof options, like trapezoidal roof options, are more vulnerable to infiltration due to the low slope.

Figure 14. Existing standing seam metal roofs at the Maloof complex

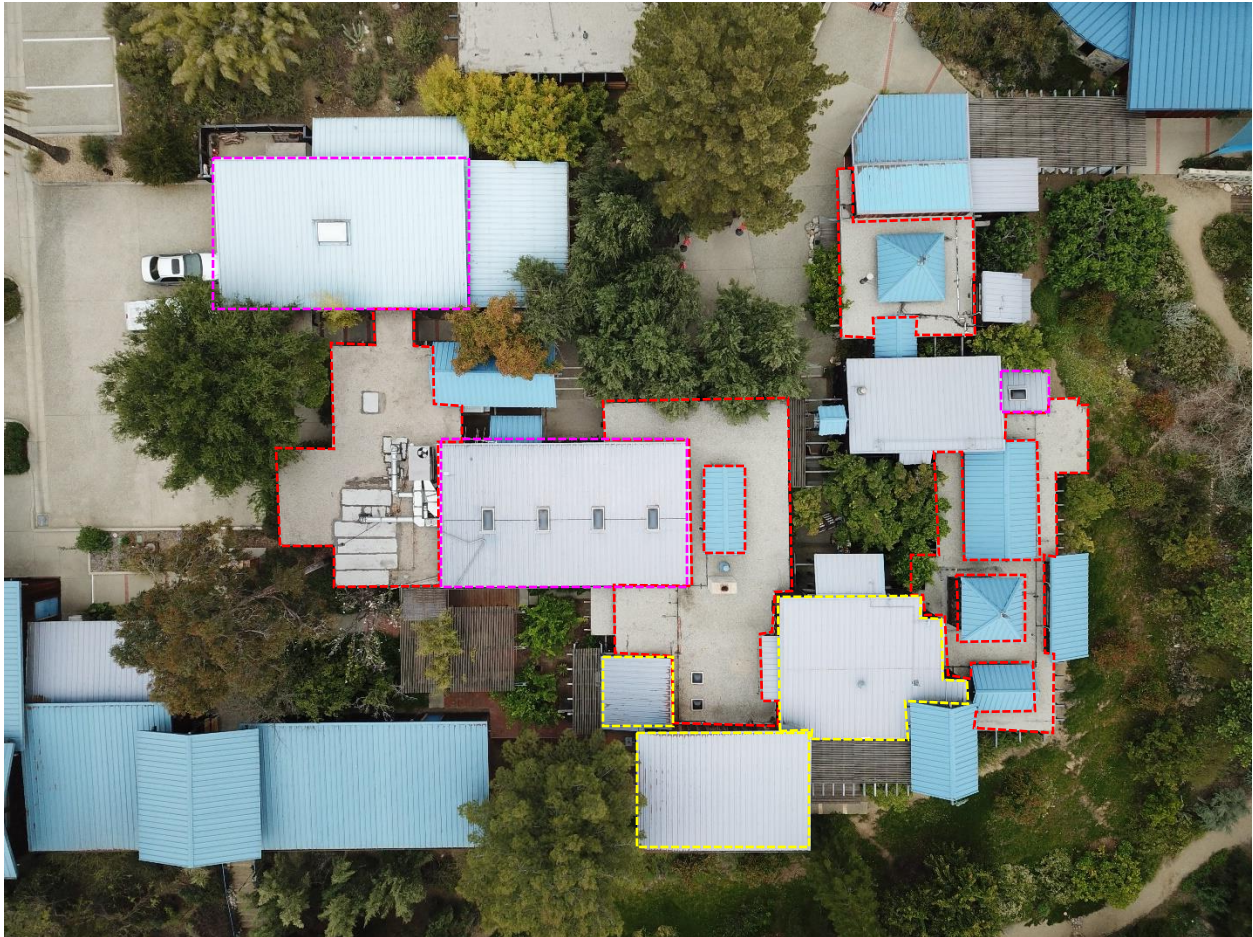
Figure 18. Aerial image of complex with flat roofs shown to be replaced with dashed red boundary lines and metal roofs to be replaced with magenta dashed boundary lines. Roofs with yellow dashed boundary lines are currently designated as alternate roofs for consideration of replacement based on poor insulative performance.

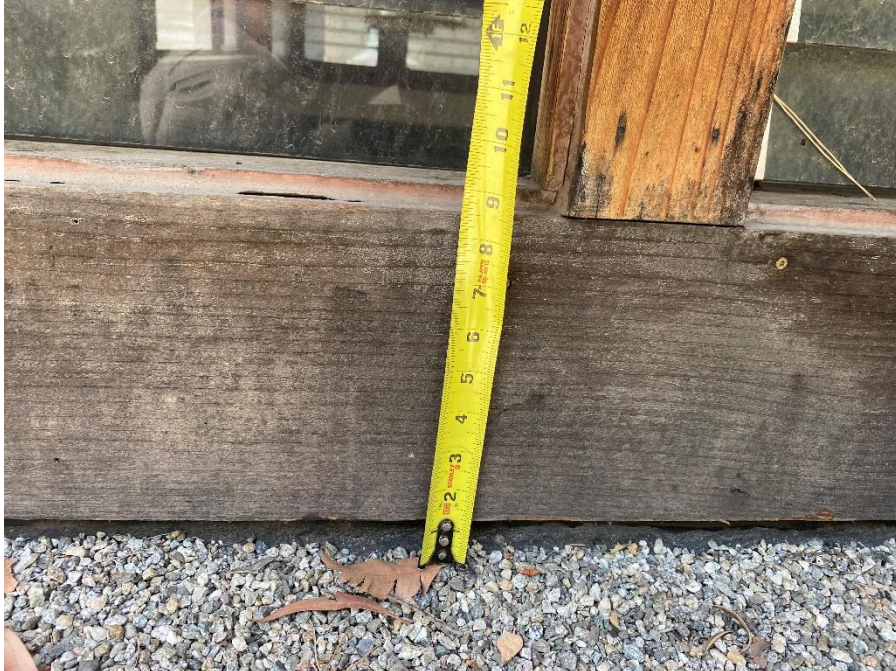
Figure 24. Example of very little available flashing height below clerstory window.

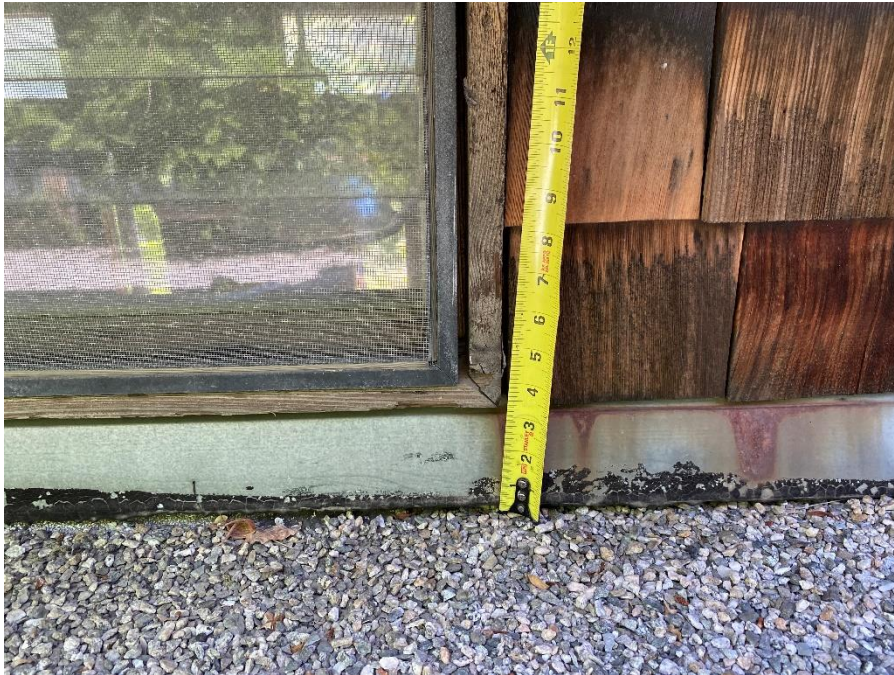
Figure 25. Example of very little available flashing height below existing window and shingle cladding.

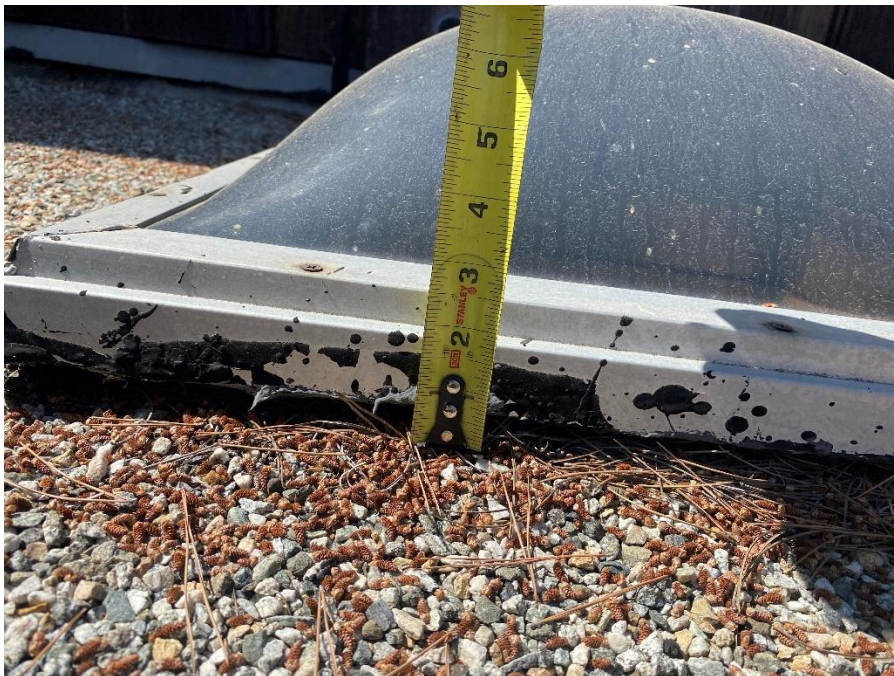
Figure 26. Example of very little available flashing height at skylight.
