FINDING OF EFFECT

Sam and Alfreda Maloof Compound Roof Replacement
(Main House, Workshop 1, Workshop 2, and Guest House)
Alta Loma, Rancho Cucamonga, San Bernadino County, California

June 30, 2023

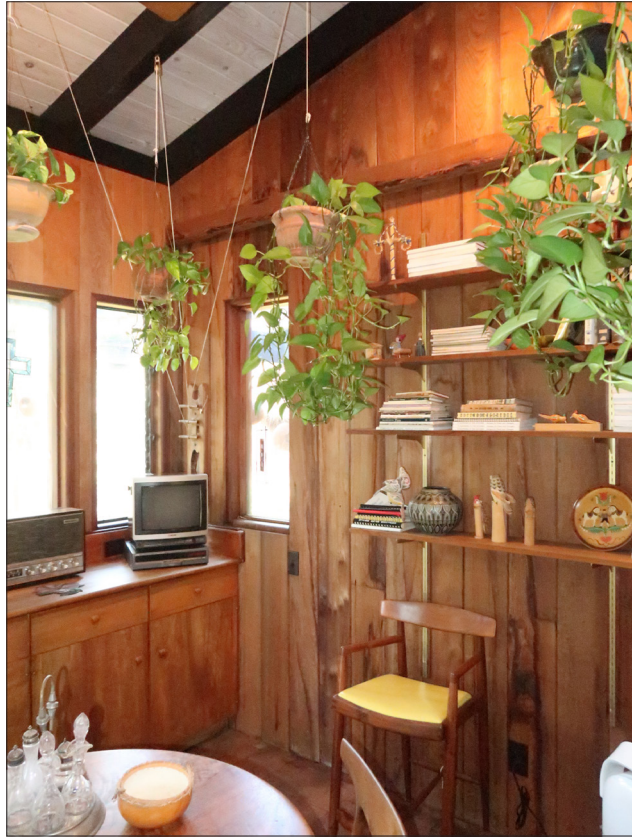
Image 23: Main House, interior at breakfast nook (Chattel, 2022)

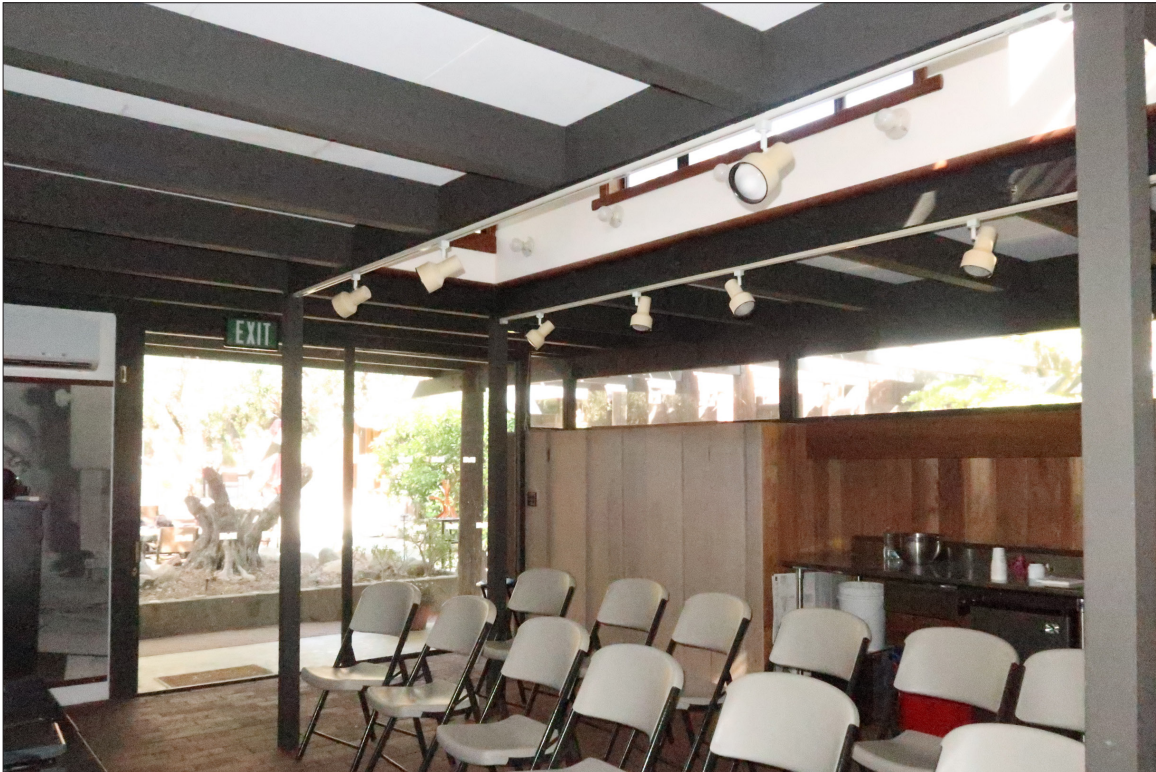
Image 25: Main House, interior at conference room, view northeast (Chattel, 2022)

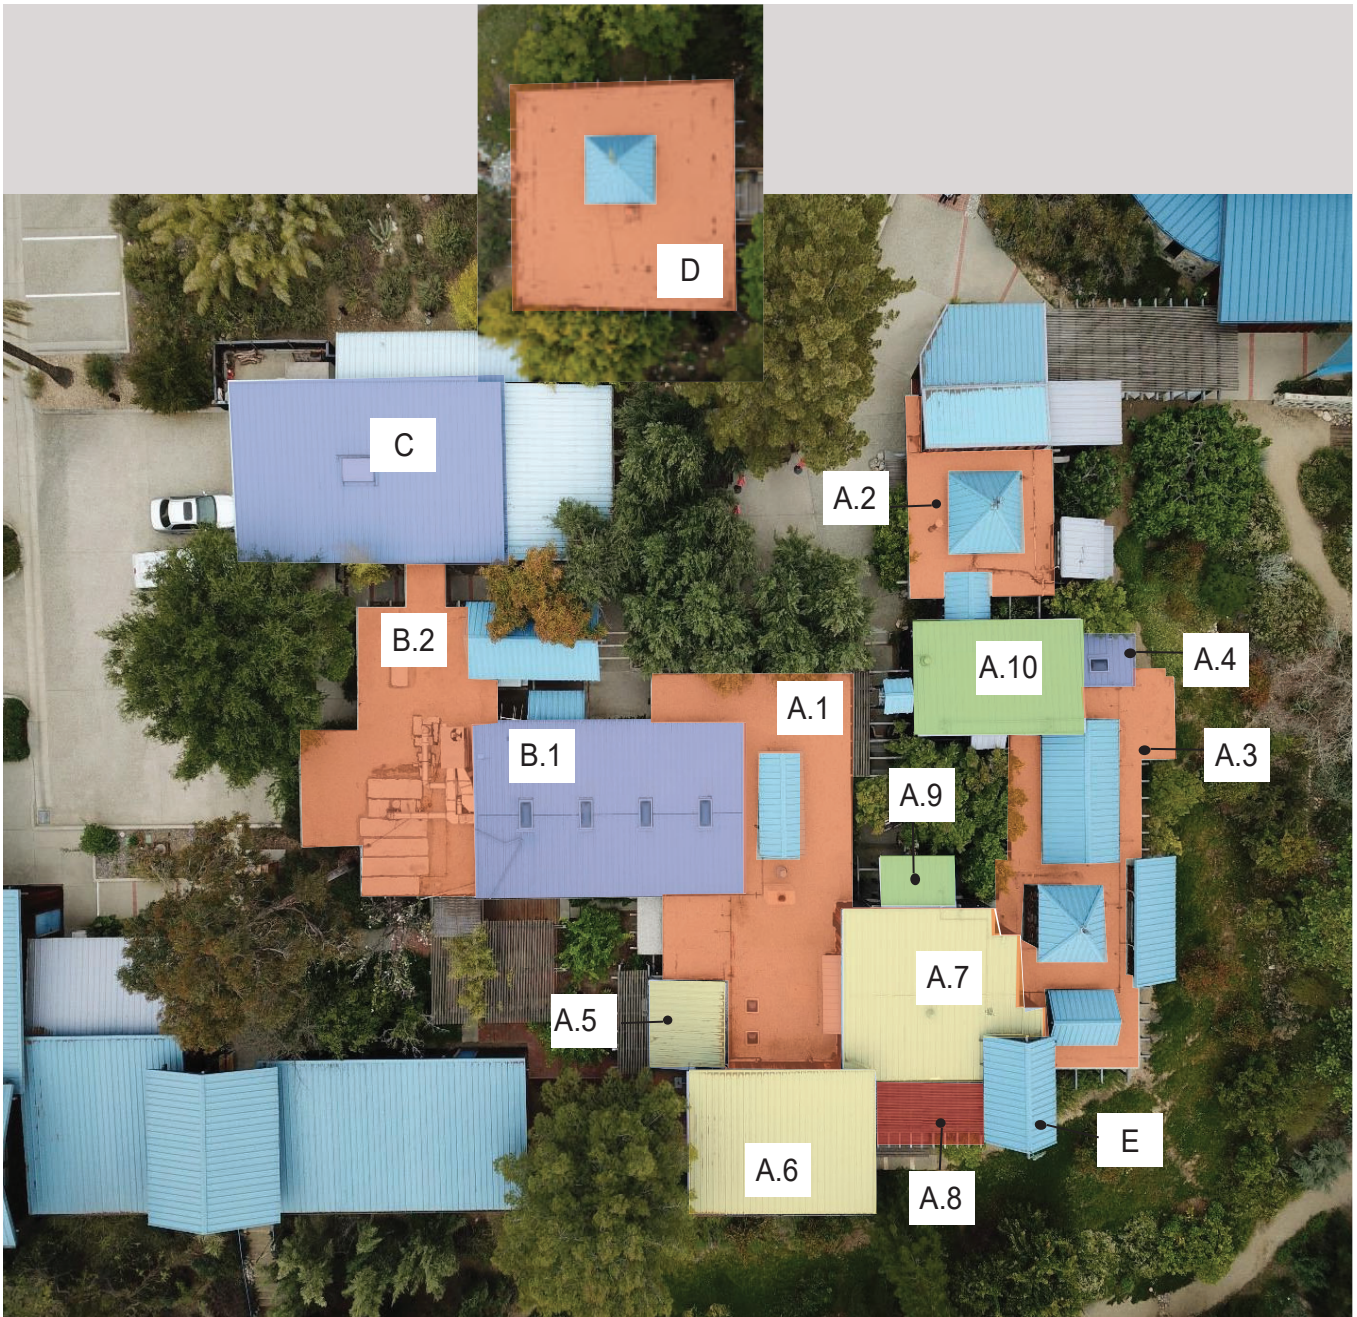
Aerial image of Maloof Compound proposed repair and replacement of roofs. Orange indicates flat roofs to be replaced, purple indicates metal roofs to be replaced, red indicates balcony trellis to be replaced, yellow indicates metal roofs that are additive alternate (high priority), green indicates metal roofs additive alternate (low priority), and blue indicates typical trapazoidal sheet metal roofs.

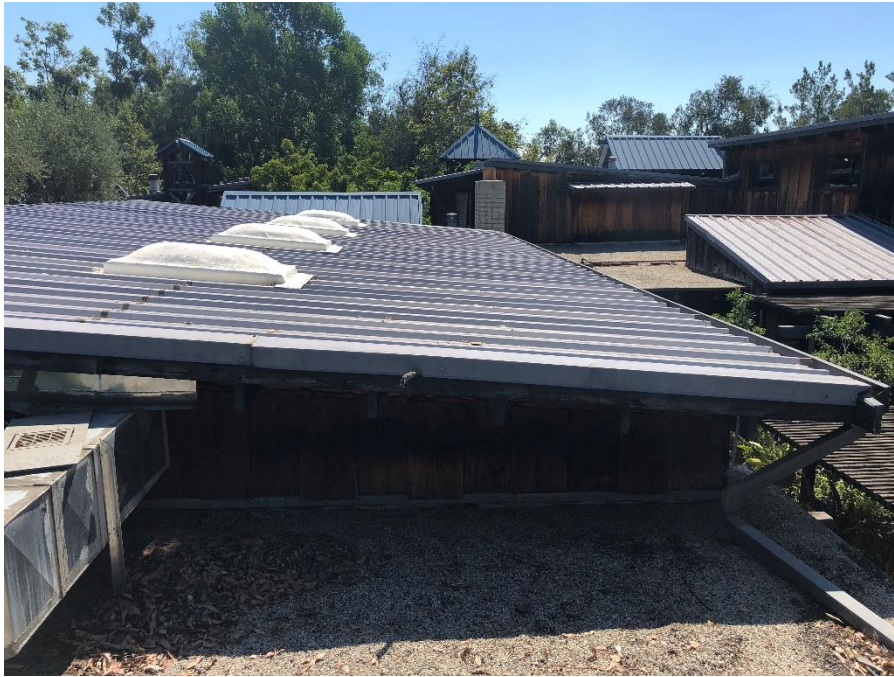
- Limited slope is present at the metal panel roofs (Workshop 1, Workshop 2, and Master Bathroom). The National Roofing Contractors Association (NRCA) recommends that architectural metal panel systems in general have a minimum 3:12 slope. For metal panel roofing with exposed fasteners, 4:12 slope (33.3%) is recommended.
 - The Workshop 1 slope is 8.75%
 - The Workshop 2 slope ranges between 5.94% to 7.1%
 - The Main House Master Bathroom slope is 13.5%
- The majority of the deficiencies noted at the metal panel roofs are related to penetration detailing (including skylights), transitions to walls, and at transverse seams.
- Crickets are not present at the high side of skylights as are recommended by NRCA in metal roofing.

Figure 27. Example of low slope at Workshop 1.
